OCEAN ENGINEERING AND CONSTRUCTION PROJECT OFFICE
CHESAPEAKE DIVISION
NAVAL FACILITIES ENGINEERING COMMAND
WASHINGTON, D. C. 20374

INDIAN ISLAND MOORING PROJECT PHASE II COMPLETION REPORT

**FPO - 1 - 84 (2)
MARCH 1984**

**ROBERT TAGGART INCORPORATED
FAIRFAX, VIRGINIA**

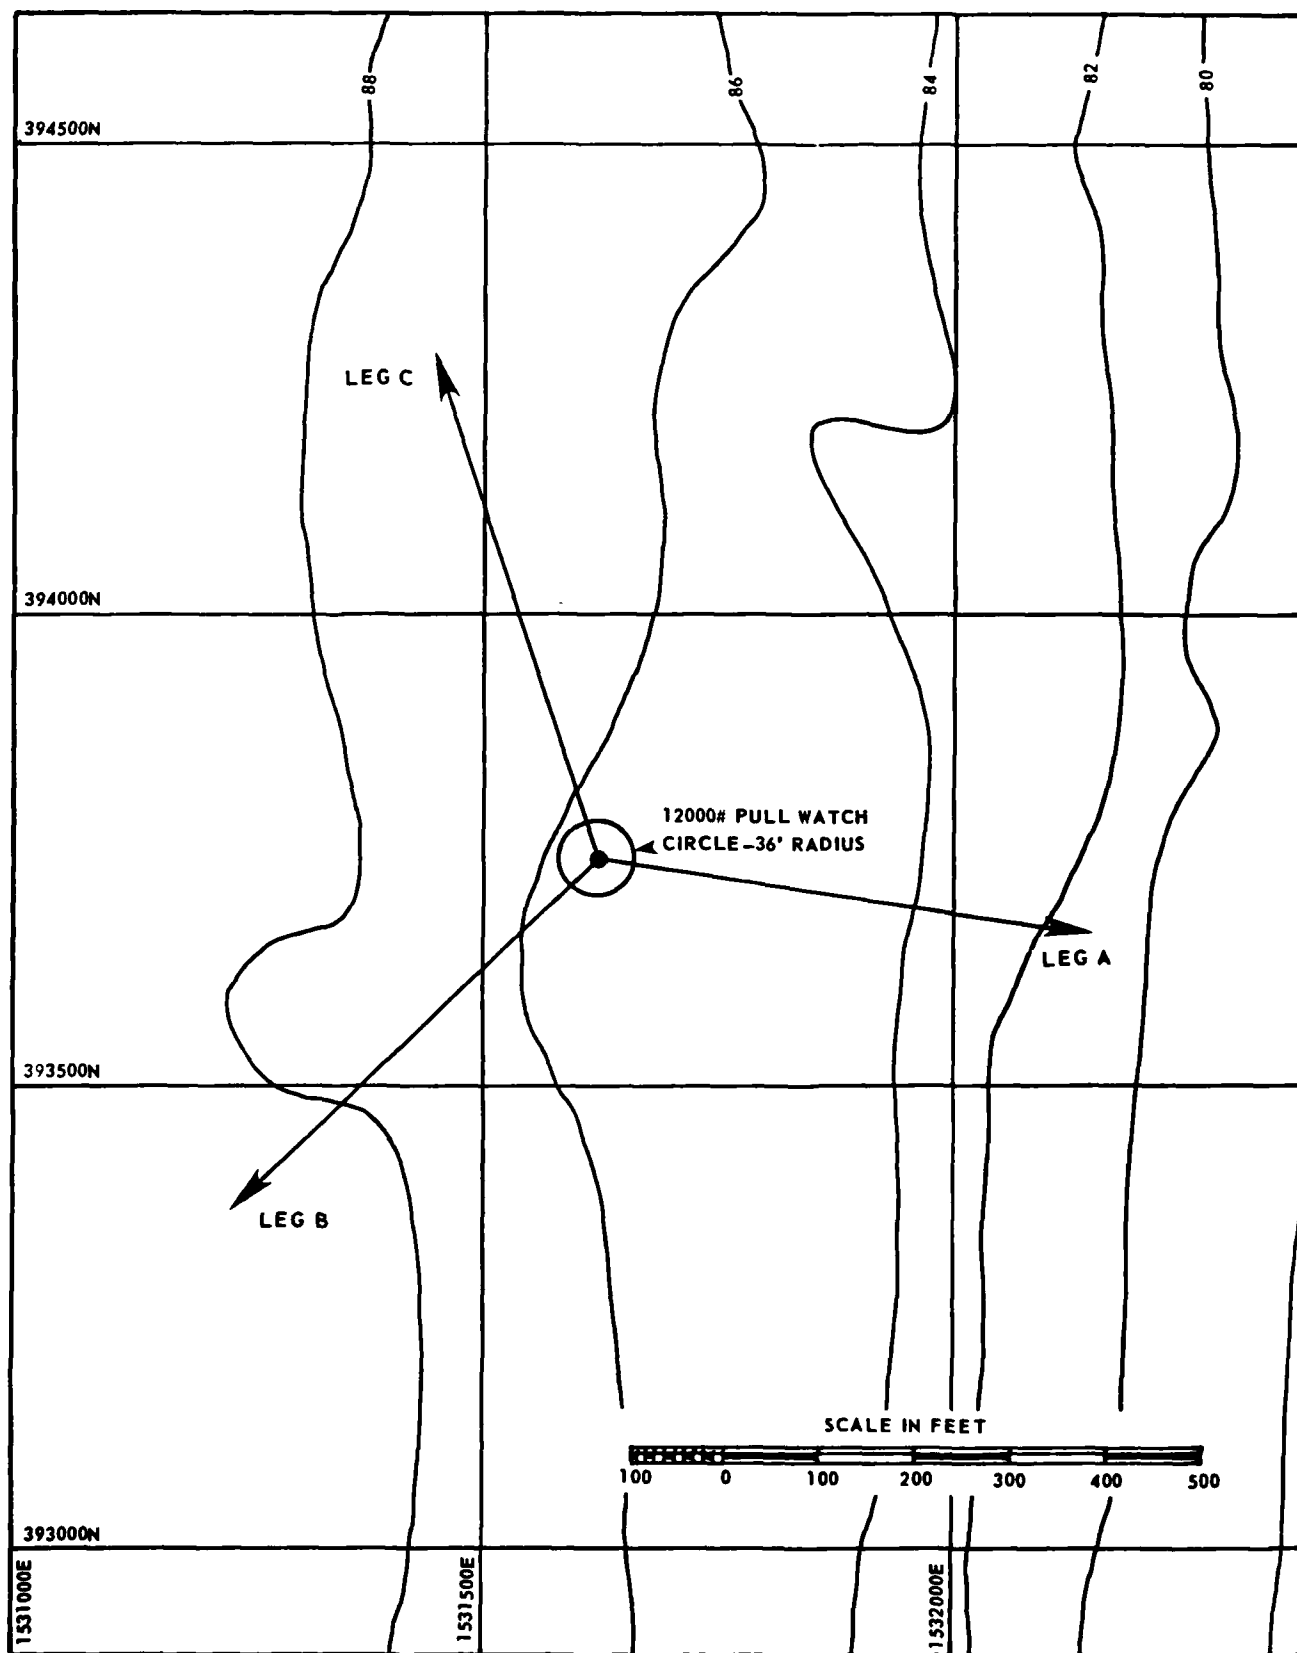
FIGURE 4-33

A replacement dynamometer was obtained from the Puget Sound Naval Shipyard. At 1500 on 29 August, the large tug headed back out for Mooring Buoy #4 to attempt once again to conduct a pull test. A heavier pennant (1 inch wire rope) was used for the bridle and the test was conducted without incident. However, all radial buoy movements exceeded specified values.

FINAL LOCATION OF MOORING BUOY #4 RELATIVE TO
WASHINGTON STATE LAMBERT NORTH ZONE COORDINATES

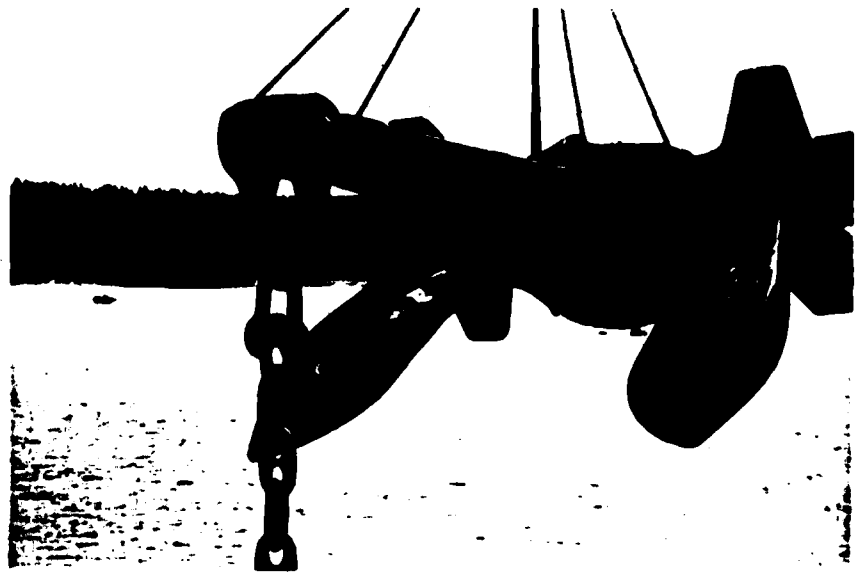
FIGURE 4-35

DAMAGED CRANE BLOCK ASSEMBLY
ANCHOR STILL SUSPENDED

On 30 August, the Army BD crane barge was towed to Puget Sound Naval Shipyard for repairs to the damaged rigging. Fortunately, a Navy YD crane barge with operator was available at PSNS to be used as a substitute for the Indian Island mooring project. The Finger Eater was transferred from the BD to the YD and the YD was towed to Indian Island so that operations could be resumed.

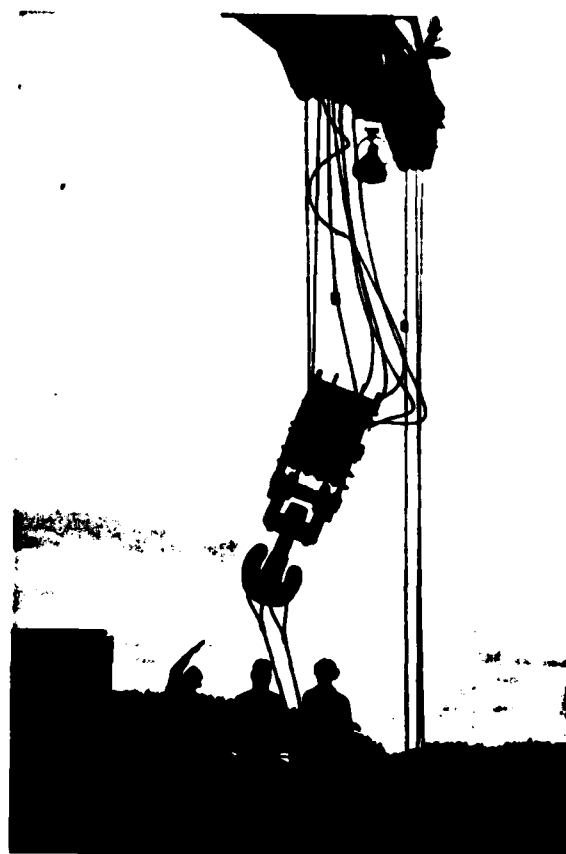
FIGURE 4-37

**CRANE BLOCK ASSEMBLY
WITH LOAD REMOVED**

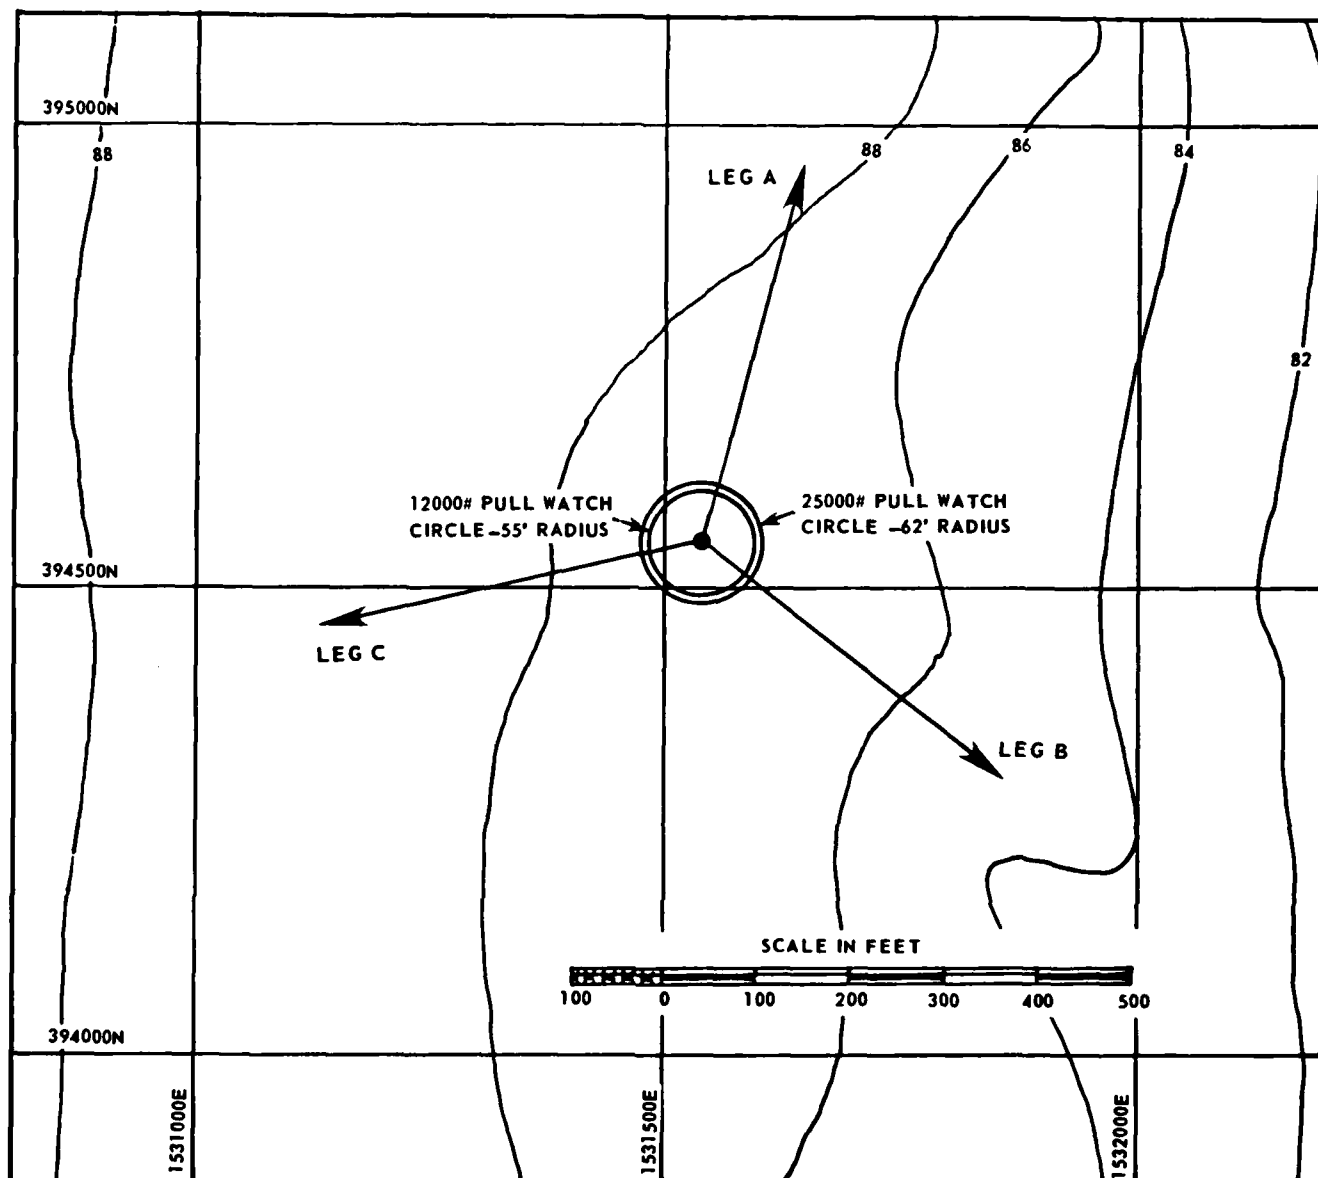
FIGURE 4-38

The 100-foot tug, rigged for the pull test, went back out to Mooring Buoy #1 at 1620. One set of pull tests were conducted with a 12000-pound pull and a second set were conducted with a 25000-pound survivability pull. The results of these pull tests, together with the locations of the buoy and anchors are shown in Figure 4-38.

FINAL LOCATION OF MOORING BUOY #1 RELATIVE TO
WASHINGTON STATE LAMBERT NORTH ZONE COORDINATES

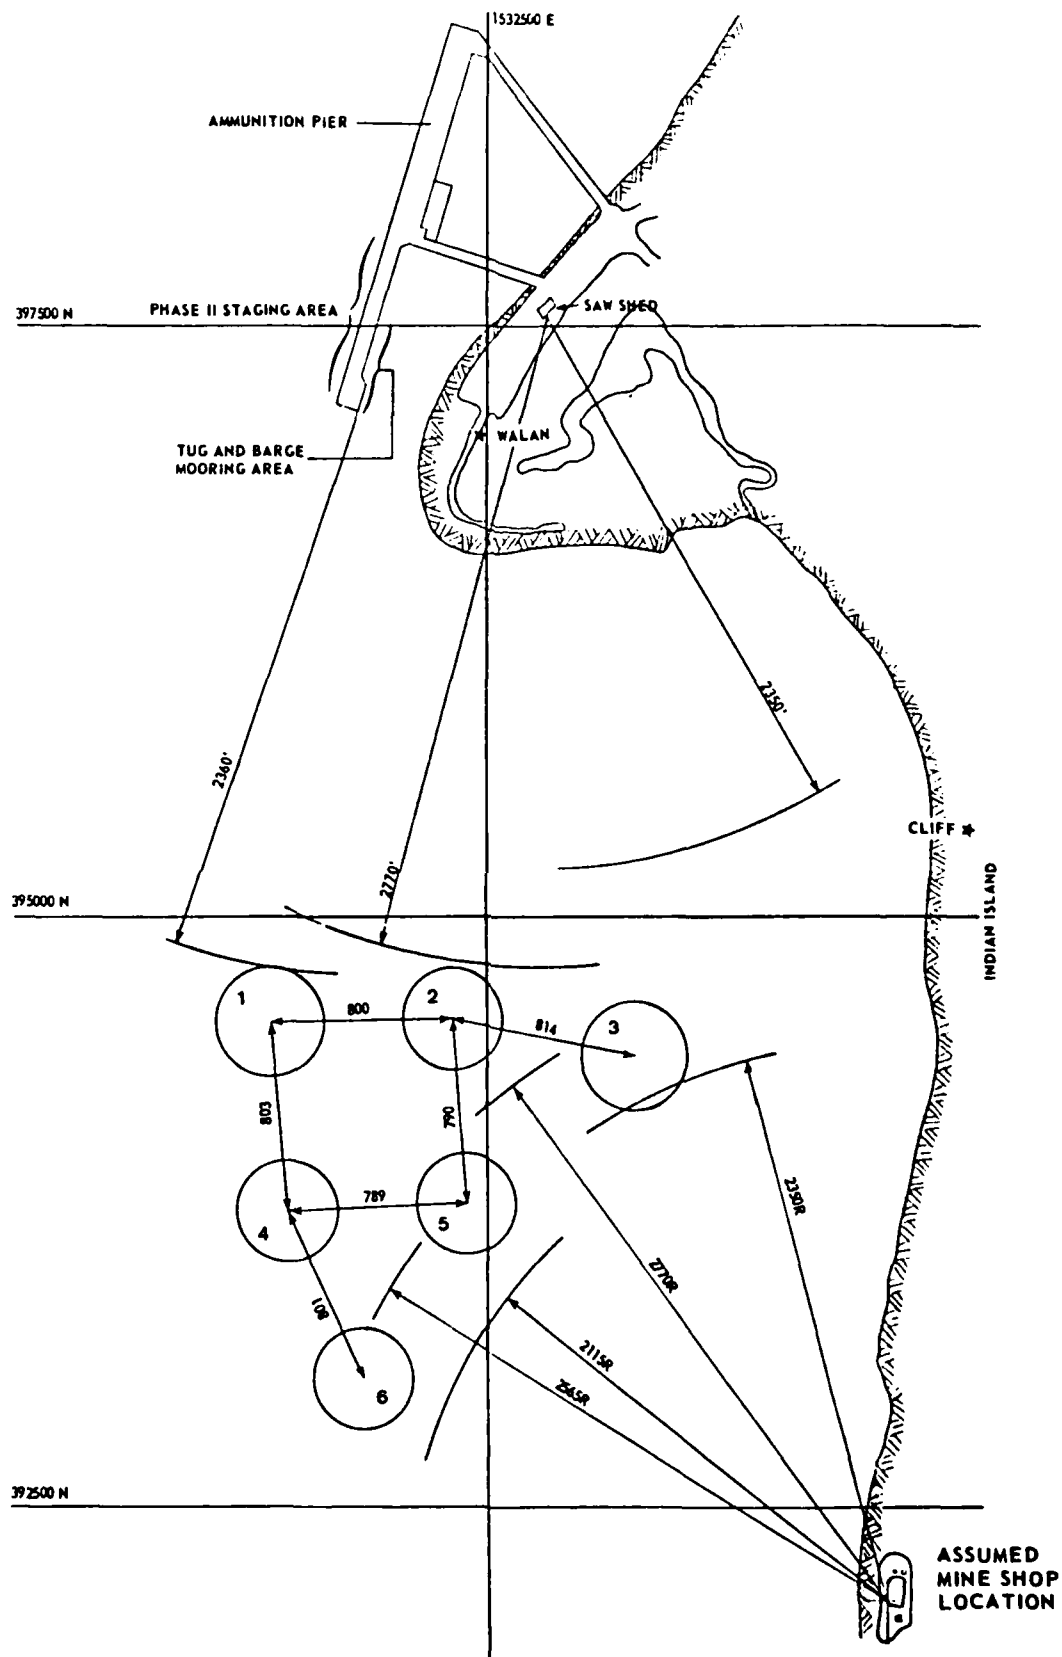
FIGURE 5-4

WATCH CIRCLES OF AMMINITION BARGES WITH
RESPECT TO ESQD RADII FROM SHORE FACILITIES

In Figure 5-4 the watch circles of the ammunition barge sterns are shown in relationship to the specified radii from fixed points on Indian Island, namely the small craft pier at the south end of the ammunition pier, the saw shed on Walan Point, and the mine shop south of the mooring array on the Indian Island shoreline. These specified ESQD radii from shore points were calculated without the allowance for the construction error that was included in the barge spacing calculation. As a result, any overlap of these arcs with the barge stern watch circles represent a failure to meet the mooring location specifications. It can be seen that these locations are met in all cases except for the distance of Mooring Buoy #3 from the mine shop where the watch circle overlaps the 2350-foot arc by 54 feet.

Although the exact location of the mine shop is not certain, it appears that some change in the allowable ammunition load for barges moored to buoy #3 might be in order. The curve of ammunition weight versus distance to critical shore points indicates that reduction of the load from 150 kips to 144 kips would be required to compensate for the discrepancy in the position of buoy #3. It is therefore recommended that the specified loading for barges moored to this buoy be reduced to 125 kips.
